# MARC4 Microcontroller Enhancement Report

**MARC4**

**Enhancement  
Report**

4668D-4BMCU-02/08

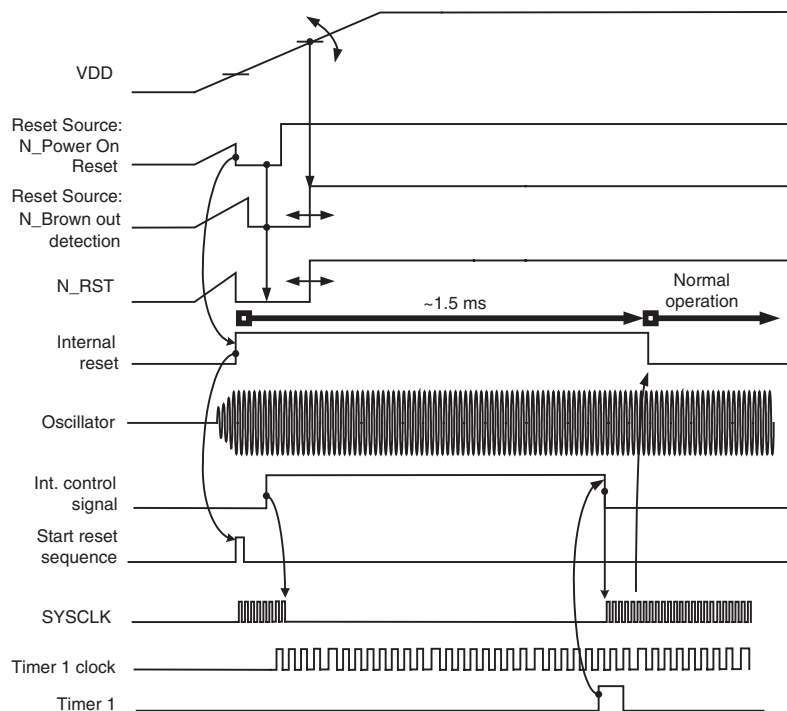
Figure 2-1. Normal Reset Function

The input to the internal reset signal generator is *N\_RST*. It is build from a couple of different reset sources (described in the corresponding datasheets under “Master Reset”). One is the *N\_Power\_On\_Reset* and another one is the *N\_Brown\_Out\_Detection* that ensures a correct VDD level before *N\_RST* ends. With a rising VDD, the first signals that become active are the *N\_Power\_On\_Reset* and the internal RC-oscillator. *N\_Power\_On\_Reset* forces *N\_RST* to a low level, starting the *internal Reset*. The rising edge of *internal\_Reset* generates a *Start\_Reset\_Sequence*-pulse, thus enabling *SYSCLK* to deliver initialization pulses for different flip-flops. It is also used to set an *internal control signal*, responsible for the reset sequence, to high. Three clock pulses later *SYSCLK* is disabled, while the reset sequence proceeds under timer 1 control. If timer 1 has finished the *internal control signal* ends and *SYSCLK* is enabled again to complete the *internal reset*. Under normal conditions or with different VDD rise times this works quite well. Even a voltage drop at VDD down to a level of approximately 1.3V does not interfere with the circuit.

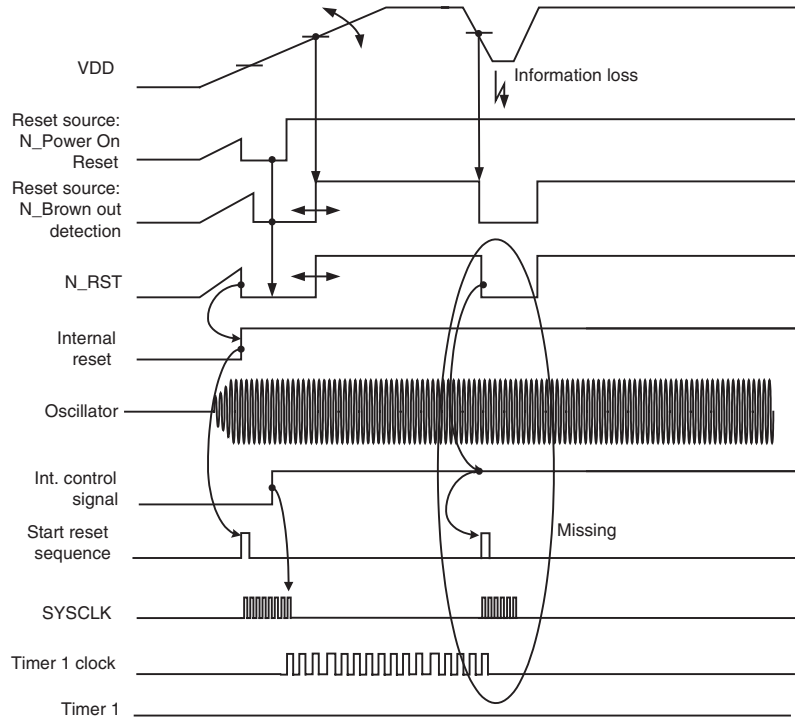
**Figure 2-2.** Reset Function Due to Bouncing

In case of a voltage drop below ~1 V during the reset sequence, it is possible that some already initialized flip-flops may lose their information. As the internal reset cannot be interrupted the reset sequence does not restart (circled in Figure 2-2) and the flip-flops concerned will not be initialized again. If this happens to the flip-flop responsible for the clock selection of timer 1, it could lead to a deadlock or lock-up condition where the circuit is not able to finish the reset and start operating.

The only way to leave this deadlock or lock-up state and return to proper operation is to disconnect the power supply. Wait a few seconds to discharge all internal and external capacitors and then connect the power supply again.

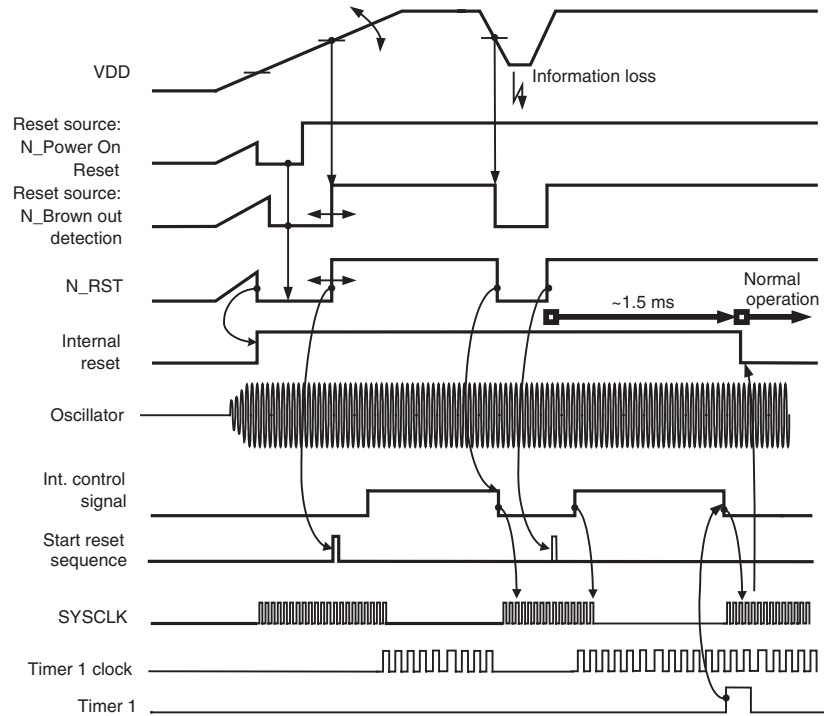
**Figure 2-3.** Enhanced Reset Function

1. The starting point of the reset sequence is moved to the rising edge of the  $N\_RST$  signal ensuring that the initialization starts operating under proper VDD conditions.
2. The  $N\_RST$  signal always restarts the reset sequence. This is the same condition as for power on. All flip-flops and registers that may have lost their information during the voltage drop are initialized again and the circuit starts operating properly.

This enhancement is fully compatible with the former normal reset operation and does not require any changes to either the software nor the application board for parts already in production.

The modification is performed by a minor change of the internal wiring (metal\_mask) only.

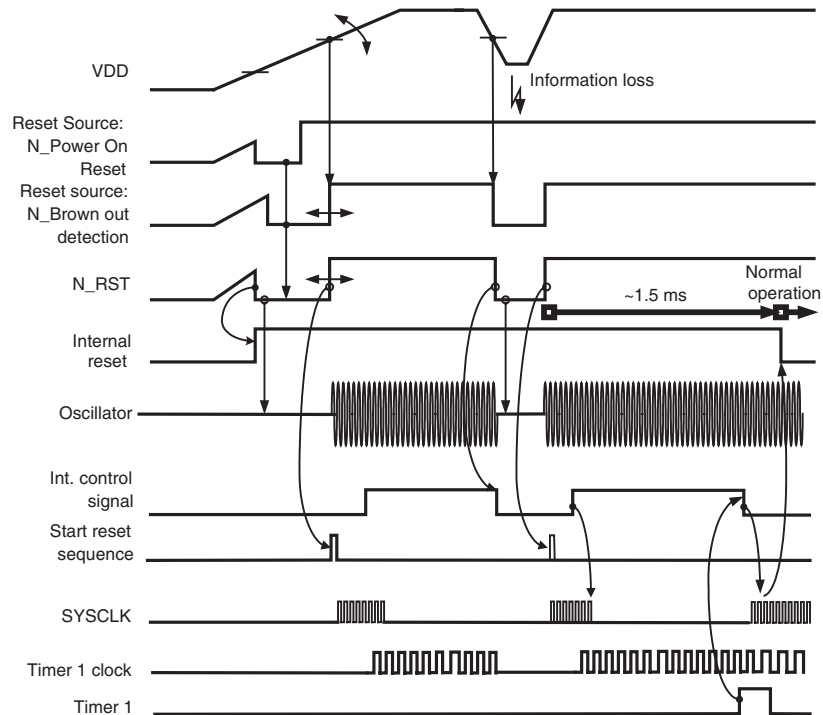
**Figure 2-4.** Enhanced Reset Function (Low Power)

1. The starting point of the reset sequence is moved to the rising edge of the  $N\_RST$  signal, ensuring that the initialization starts operating under proper VDD conditions.
2. The  $N\_RST$  signal always restarts the reset sequence. This is the same condition as for power on. All flip-flops and registers that may have lost their information during the voltage drop are initialized again and the circuit starts operating properly.
3. Reduce the power consumption as long as the supply voltage stays below the operating range. This is performed by stopping the oscillator (and all derived clock signals) while a reset condition is active ( $N\_RST = \text{low}$ ).

This enhancement is fully compatible to the former normal reset operation and does not require any changes to either the software or the application board for parts already in production.

The modification is performed by a minor change of the internal wiring (metal\_masks, via\_mask) only.

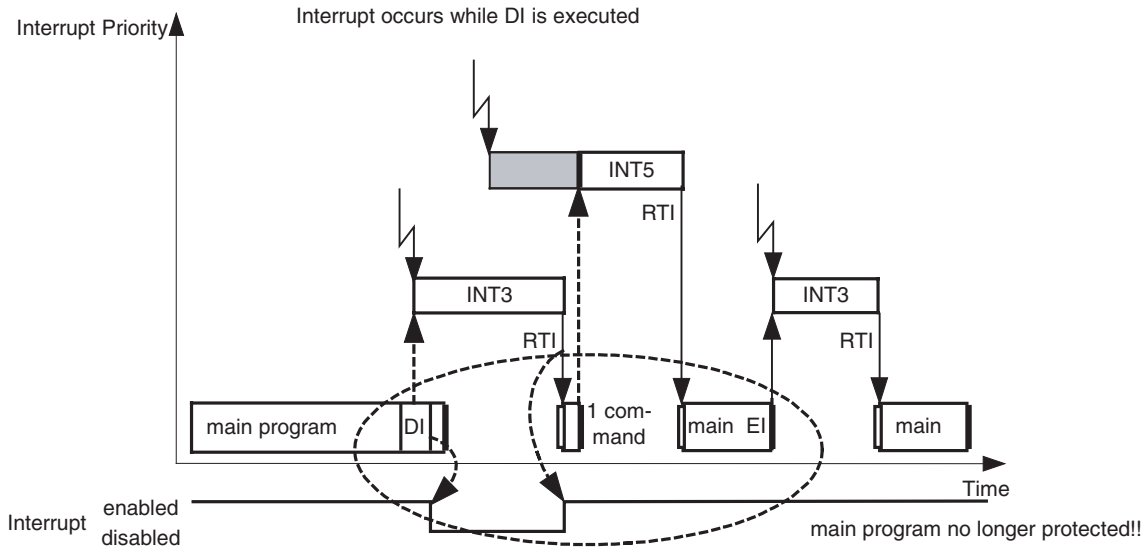
**Figure 5-3.** Special Conditions

If an interrupt occurs during a special clock phase while the DI instruction is being executed, the circuit acknowledges the interrupt, jumps into the interrupt service routine and at the same time finishes the DI instruction. Now the interrupt enable flag is reset (disable interrupt) and further interrupts are stored in the pending register. Leaving the service routine, the RTI (return from interrupt) sets the interrupt enable flag (enable interrupt). Program execution now continues at the instruction following the DI, but with interrupts enabled. If another interrupt occurs the DI no longer prevents the program from being interrupted.

The only way to ensure proper DI execution is to test that DI has been executed. This is best performed in a loop, until the interrupt enable flag is reset. Now, if the DI is interrupted the program returns into the loop, executes DI again and then continues with the program to be protected.

In addition to the above described safe method, there is another way to drastically reduce the probability of a DI-malfunction. Just use 2 consecutive DI commands instead of only one. If the first one is disturbed by an interrupt, the return from interrupt will land at the second DI and continue normal program execution.

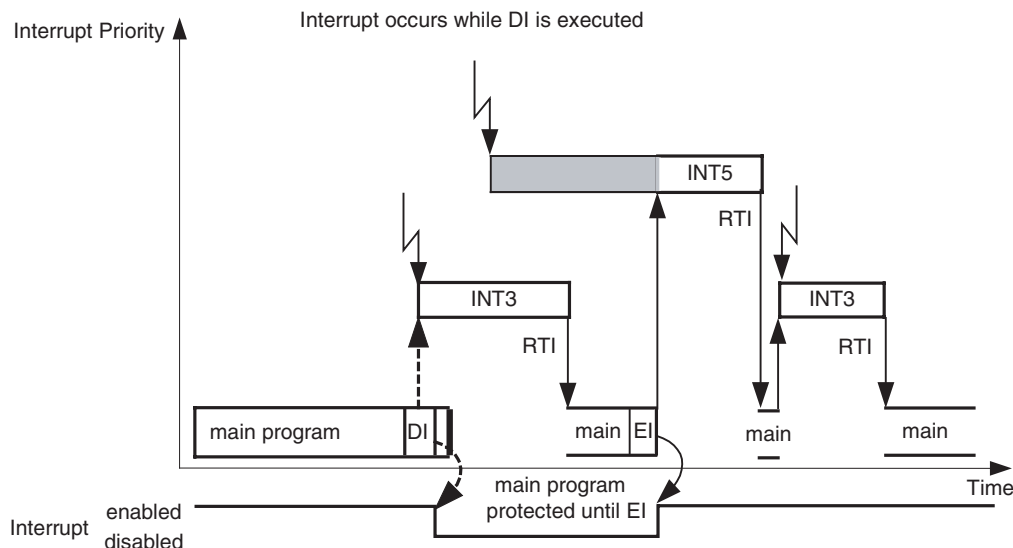
**Figure 5-4.** Enhanced Interrupt Execution

The enhancement introduced to the circuit is as follows. Due to the fact that it is not the DI itself that causes possible problems but the interrupt that follows after the return from interrupt (RTI), we modified the function of the RTI instruction. From now on the RTI not longer perform an EI (enable interrupt).

The described solution does not require any changes in the application hardware or software as long as the \$NOOPTIMIZE or the \$OPTIMIZE – SAVECONXT switch has not been used for compiling the interrupt service routines.

The described modification is performed by a minor change in the metal-2 layer.
